PROPERTY INSPECTION REPORT

Property Address: ---- S.
Chicago IL 606--

Inspection Date: August 5, 2011

INSPECTION PHOTO SUPPLEMENT: RE: report 8416m
Scope: photos of a sample of reported conditions; refer to narrative report

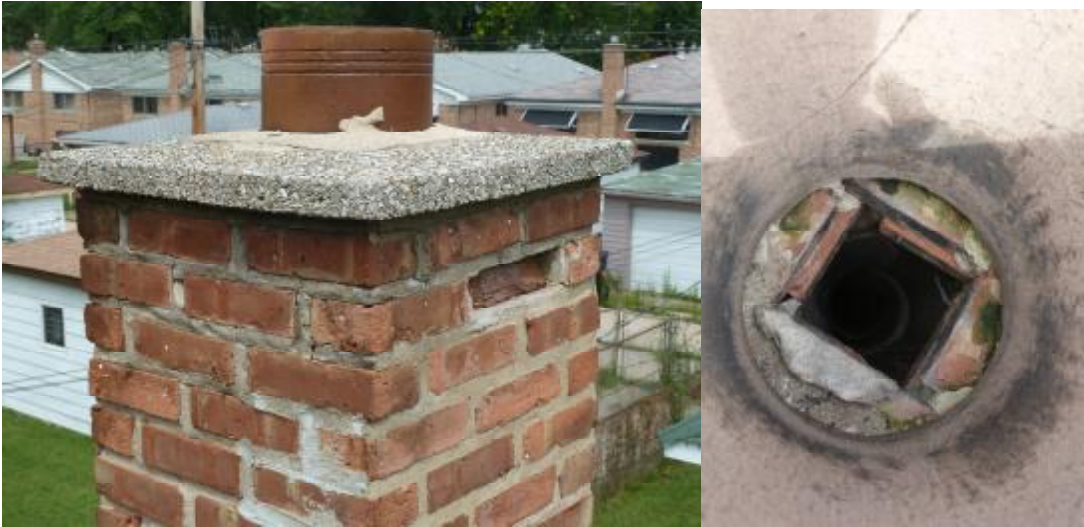
Chimney in & out

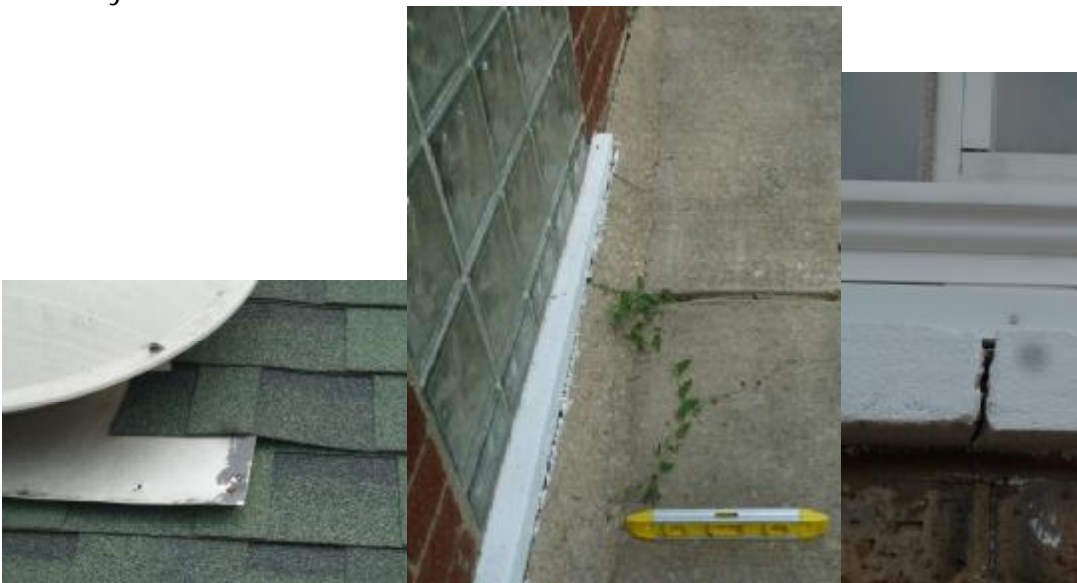
Component	Condition	Comments
<u>Wall Coverings</u>		
Brick	Fair	<p>**Brick homes require periodic tuckpointing/repair of mortar joints. Degree of cracking/wear present at masonry, face brick overall OK but tuckpointing is recommended. Note cracked stone window sill, NE BR N window.</p> <p>Tar patching or cement used at lower wall areas, inadequate to stop seepage.</p>
Stone	Deficient	
clearance to soil	See Comment	
<u>Trim</u>		
Aluminum	See Comment	<p>Leave some foundation exposed for clearance betw. wall covering & grade (prevent water, etc.)</p> <p>Metal soffit trim is loose at rear.</p>
<u>Doors</u>		
Front	Functional	<p>Caulking will fail in time. Check regularly, remove old cracked caulk prior to reinstallation.</p> <p>Gap is noted under storm door, threshold is loose.</p> <p>To insure safe egress, client is advised against double-keyed deadbolts.</p>
Side	See Comment	
Rear	Not Applicable	
<u>Windows</u>

Component	Condition	Comments
<u>Walks & Steps</u>		
Walks Steps	Deficient Deficient	Patching was used to address uneven slabs of concrete, not permanent repair, has already re-cracked. Concrete has cracked and settled, incl. area to S of kitchen where concrete slopes to house. Concrete isn't flat, trip hazard noted, near S door.
<u>Driveway</u>		
Concrete	Functional	<i>**A degree of cracking and wear is expected in our climate, especially on concrete which has been excessively salted. Consider de-icing products which are not harmful to concrete.</i>
<u>Drainage & Grading</u>		
Property Drainage	Deficient Further Review	Grading slopes toward the building at some rear/side areas: much of rear yard plus stone area to N of home, this corresponds w/water damage in basement and needs regrading/landscaping work; consult w/full service waterproofing contractor re: exterior repairs. <i>Where feasible, maintain a positive slope away from the foundation to direct runoff away. If this is not feasible in areas, consider use of buried drain tiles (PVC pipes or polyethylene hoses in shallow gravel bed) to direct water away from the home.</i>

loose nail, powered fan; concrete sloping toward house, cracks at cement patching attempts, south wall; cracked stone sill at N bedroom window, likely an indication of a foundation wall below

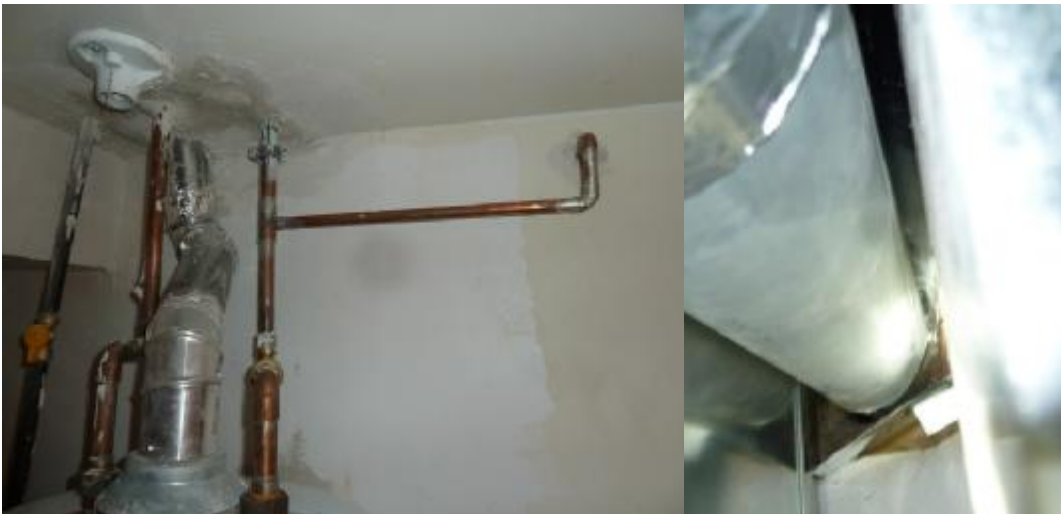
Shut Offs	Present	
Leaks Detected	None Detected	
Supports	Functional	
<u>Water Heater</u>		
Water Heater Tank	Functional	<p>Single wall exhaust vent was improperly concealed.</p> <p>Water heater exhaust is backdrafting considerably/poses safety hazard. Its exhaust vent goes up, then across (over beam) then down, before reaching chimney where the furnace exhaust vent meets it. Down run on gas appliance vent shows lack of care/amateur workmanship; note sheetmetal panels placed in front of this for no ostensible reason other than to conceal. Due to safety concern this needs correction by licensed plumbing/mechanical contractor; if verification is needed refer to People's Gas.</p>
Water Shut Off	Present	
Temp Control	Functional	
Burner	Functional	
Safety Relief Valve	Not Tested	
Exhaust Vent	Deficient	
Clearances	Safety Concern	
Ventilation	see heating pg.	
Drain Valve	Not Tested

Water heater exhaust vent installed poorly, improperly concealed, backdrafts; note lack of shutoff valve for rear hose faucet piping

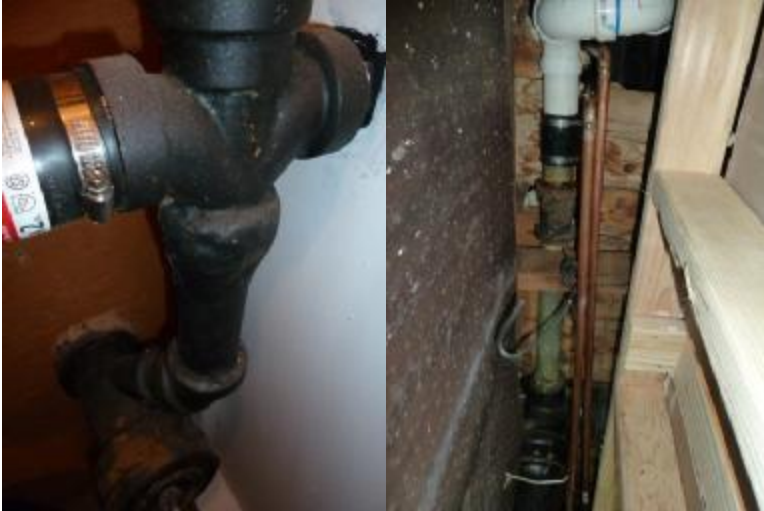
Cross Connections	None Viewed	
Main Shutoff Valve	Older Unit	
<u>Waste Piping</u>		
Drainage	Deficient	<p>Bathtub drained slowly. Despite cosmetic upgrades original galvanized steel waste pipes are re-used behind newer PVC serving kit. and tub. Note flexible tubing under full bath sink. Note how dishwasher drains to kit. waste pipe on sewer side of trap, can lead to sewer gas entering DW. Ejector pump is provided, near bath, however this lacks a check valve, is on GFCI outlet, and is served by 1.5" not proper 2" diameter vent pipe. At piping in bsmt. below kit. sink, sewer odor is noted; patching not lead and oakum noted betw. pipes.</p>
Visible Leaks	See kitchen pg.	
Vents	Deficient	
Ejector Pump	Deficient	
Clean Outs	Further Review	
Supports	View Limited	
<u>Gas Piping Comments</u>		
Piping Type	Functional	<p><i>**Sub-slab sewer piping not visible; recommend contacting licensed plumber for review/repair estimate to the above plus video inspection to determine sewer condition.</i></p>

Patching betw. pipes, site of odor; note older piping being re-used, under bathtub; 1.5" not proper 2" vent for ejector; DW enters drain on sewer side

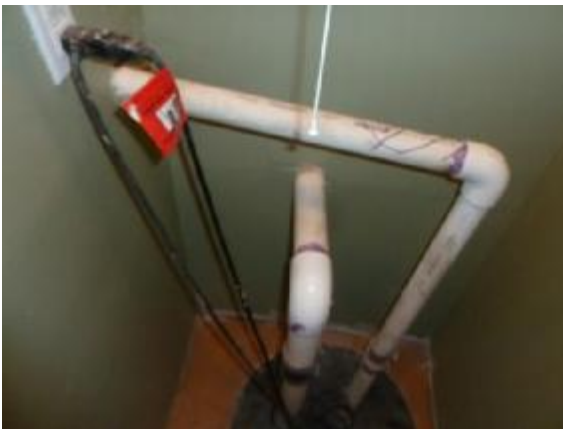
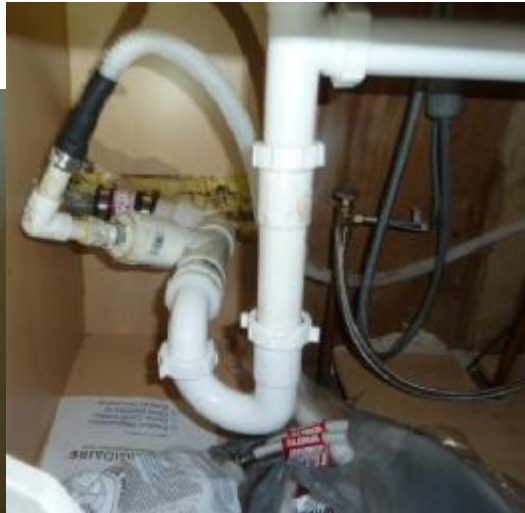
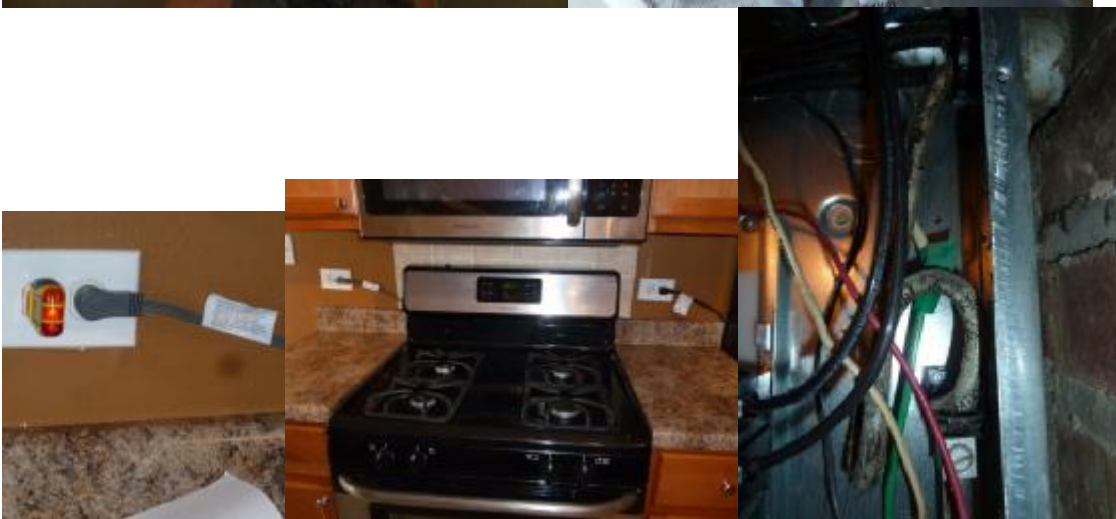
<u>ELECTRICAL</u>	14 gauge wire was too small for 20 amp breaker, right side. Ground wire was improperly spliced, 8 ga. to smaller green ground wire; small green ground is noted near water heater, needs proper ground installed by licensed elec. contractor. Outlet tested with reversed polarity at kit., left of range. Range and fridge are served by counter outlets, lack their own non-GFCI outlets. Wires are exposed where flexible cable is damaged, roof fan. Outlet at full bath is not GFCI type, and when tester was plugged into outlet, light flickered on. Note missing pullchain at BR closet light.
<u>KITCHEN</u>	Sections of baseboard are used at floor transitions betw. wood and tile. Note poor dishwasher fit in cabinetry/gaps esp. around kickplate. Small leak noted under pipes after test.
<u>BATHROOMS</u>	Note use of 2 stem not single handle anti-scald tub/shower valve. Tile has irregular surface at shower curb, poses hazard. Shower floor drainage pitch is marginal.

Reversed polarity outlet, standard non-GFCI outlets not provided for appl's, GFCI outlets not completed at counter. Spliced ground wire, main panel

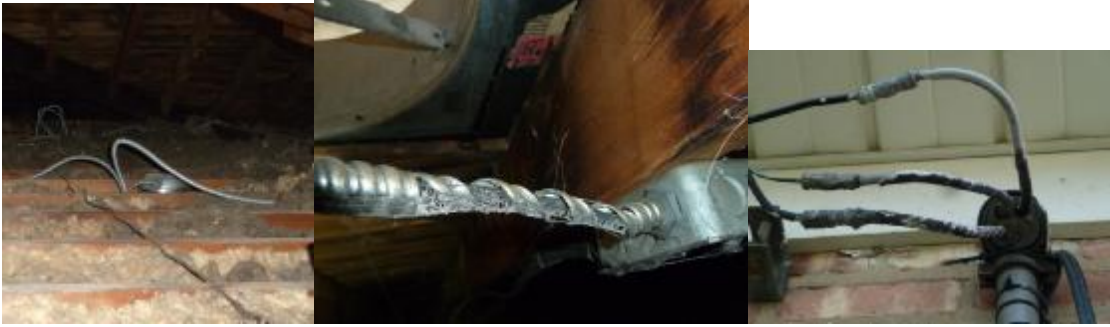
Loose cables, attic, incl. near fan; frayed insulation at elec. service wires

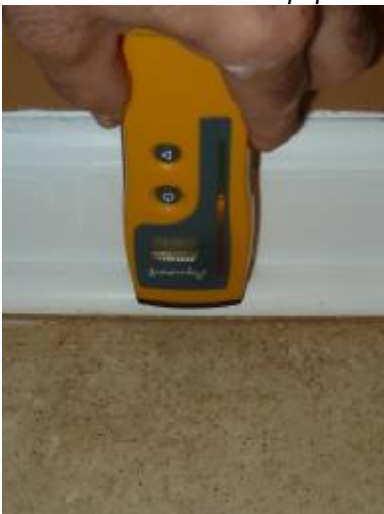
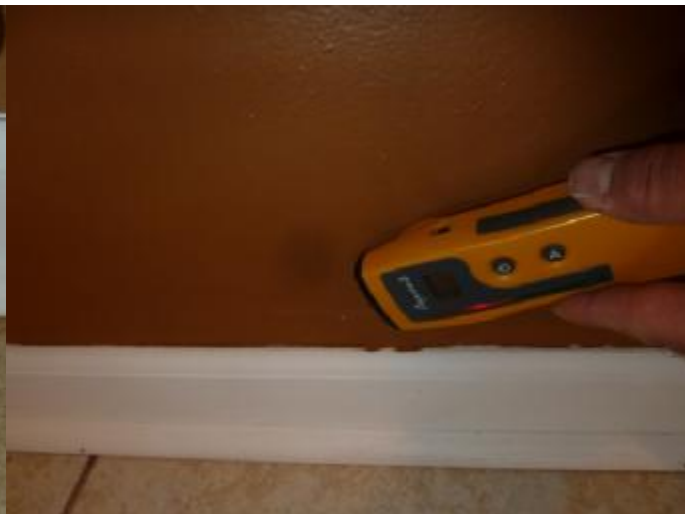
<u>INTERIOR</u>	Note visible drywall & floor patches, missing stair handrail.
<u>FOUNDATION</u>	Ongoing seepage/active water penetration was found: elevated moisture levels were detected at drywall and baseboard at north and east, incl. lower drywall under NE window. Far E end of floor is wet, behind water heater. Mold is visible at several areas: under main water valve access panel, plumbing cleanout accessible from bathroom. Partial recent repainting noted, furnace/laundry area, but mold is visible behind furnace where paint didn't reach. Recommend repair estimate by waterproofing/mold remediation contractor incl. opening sample of drywall to view foundation.

Elevated moisture level, high moisture level, incl. middle part of N wall

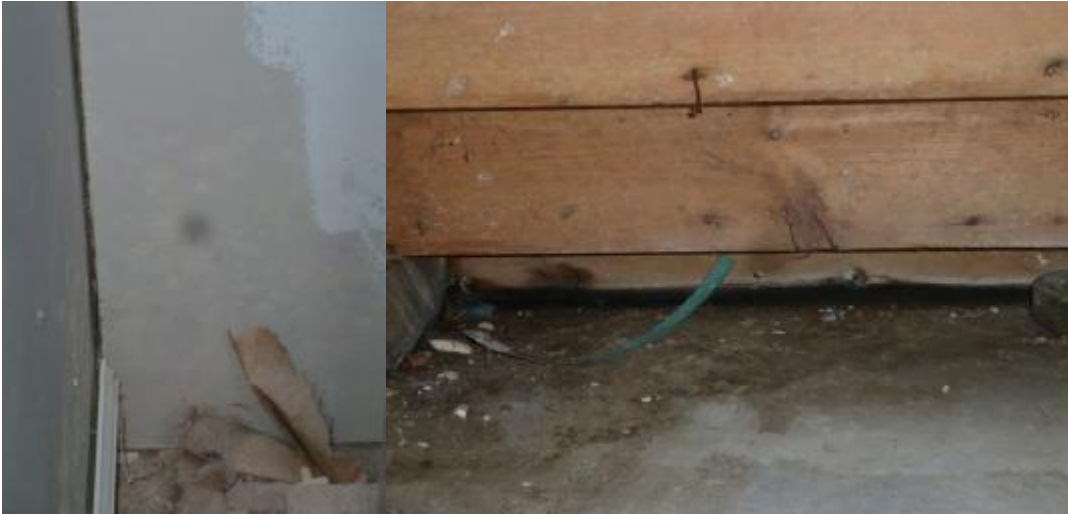
Mold at E wall, behind/left of furnace; stains at bottom of stairs; mold below access panel for main water valve; mold at plumbing cleanout area near bath
