PROPERTY INSPECTION REPORT

Property Address: ---- S.
Chicago IL 606--

Inspection Date: August 5, 2011

INSPECTION PHOTO SUPPLEMENT: RE: report 8416m
Scope: photos of a sample of reported conditions; refer to narrative report

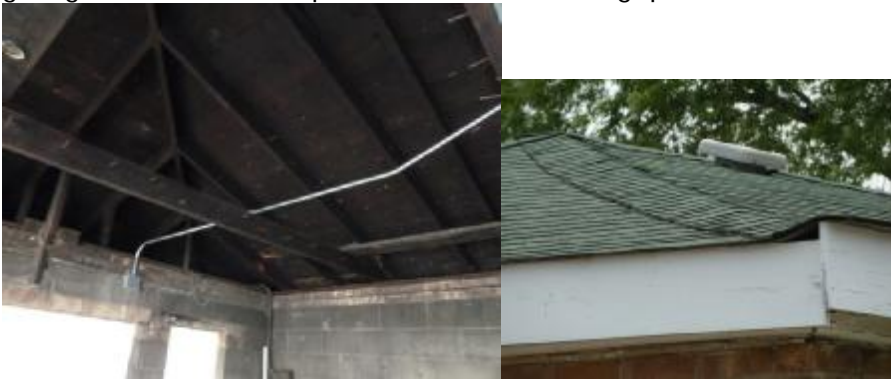
Garage is served by thinwall elec. conduit, not rigid conduit; cracking where garage meets landscape wall; interior and gap betw. roof and fascia

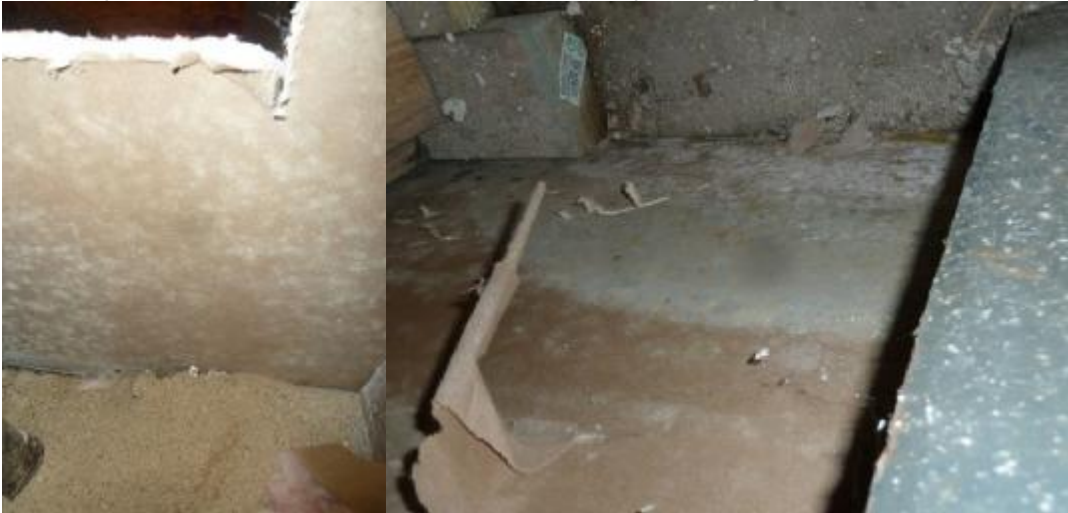
Mold at E wall, behind/left of furnace; stains at bottom of stairs; mold below access panel for main water valve; mold at plumbing cleanout area near bath
